**DEPARTMENT OF TRANSPORTATION****DIVISION OF ENGINEERING SERVICES**

Contract #: 04-0120F4Cty: SF/ALA Rte: 80 PM: 13.2/13.9File #: 1.28**WELDING INSPECTION REPORT****Resident Engineer:** Casey, William**Address:** 333 Burma Road**City:** Oakland, CA 94607**Report No:** WIR-026417**Date Inspected:** 27-Sep-2011**Project Name:** SAS Superstructure**OSM Arrival Time:** 700**Prime Contractor:** American Bridge/Fluor Enterprises, a JV**OSM Departure Time:** 1730**Contractor:** American Bridge/Fluor Enterprises, a JV**Location:** Job Site

## WELDING INSPECTION REPORT

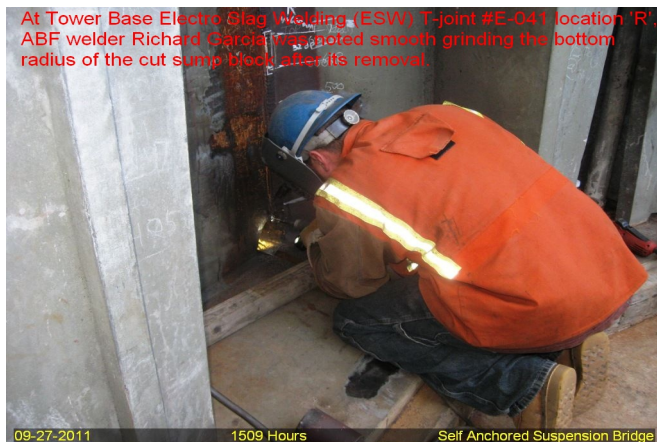
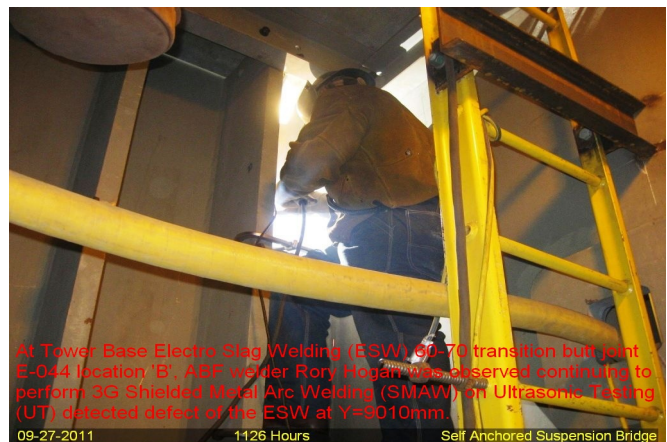
At Tower Base Elevation Electro Slag Welding (ESW) T-joint E-044 location 'B', QA randomly ABF welder Rory Hogan perform 3G SMAW first time welding repair (R1) on the Ultrasonic Testing (UT) detected defect on the internal of the vertical weld of the ESW. The welder was observed welding in the 3G (vertical) position utilizing Shielded Metal Arc Welding (SMAW) with 1/8" diameter E7018H4R electrode implementing welding procedure ABF-WPS-D15-1000-Repair Rev. 2. The boat shape repair excavation located at Y=8975mm to Y=9135mm was excavated to dimensions of 160mm long x 40mm wide x 42mm deep. The excavation was previously tested using Magnetic Particle Testing (MT) by ABF QC John Pagliero and this QA with positive result.

1. ESW location 'S' (outside) – smooth grinding of the cut and gouged radius of the sump block removal was completed but noted with linear indications. Linear indications still need to be removed. The welder has moved to ESW location 'R' and started smooth grinding the same radius as previously mentioned.
2. ESW locations 'P', 'Q', 'V' & 'T' (outside/80-100 butt joint transition) – four ABF welders were noted grinding/cleaning the ESW weld cover that include removal of strong back remnants. This is in preparation for the QC VT and NDE testing.
